Case Study:

Re-location and re-design of non-ferrous separation plant.

S. Norton & Co Ltd.

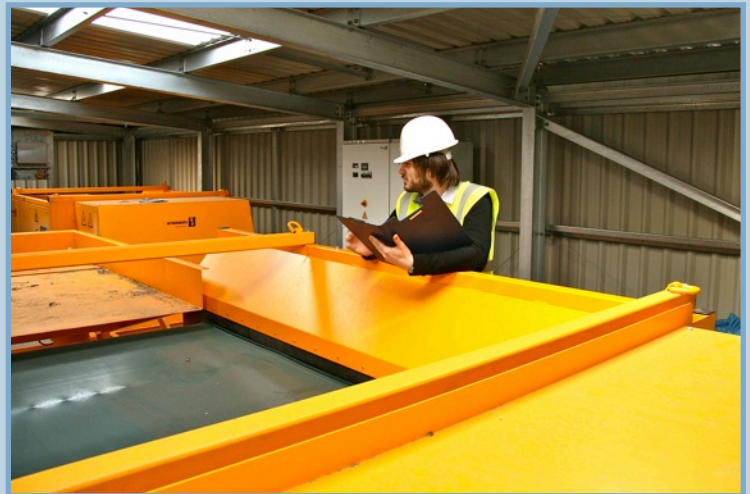
- Axion redesigned new plant layout using existing ECS units and adding one reconditioned unit.
- Plant rebuilt using 35% scrap materials.
- On-site performance tests conducted.
- Plant optimised for performance and efficiency.

- 3% improvement in metal purity.
- 3% increase in recovery rate.
- Throughput doubled.
